12 - Berg Lumber Mill Site City of Lewistown

Project Description

The Berg Lumber Mill Site [also known as the Lewistown Groundwater Investigation] is a 31-acre site resting upgrate from Big Spring Creek located on the outskirts of Lewistown. This remediation project assessed the extent of illegal industrial contaminant disposal and proceeded to remove the material from the site. Auxiliary benefits to the area included the improvement of water quality within Big Spring Creek, a recreational destination for local residents.

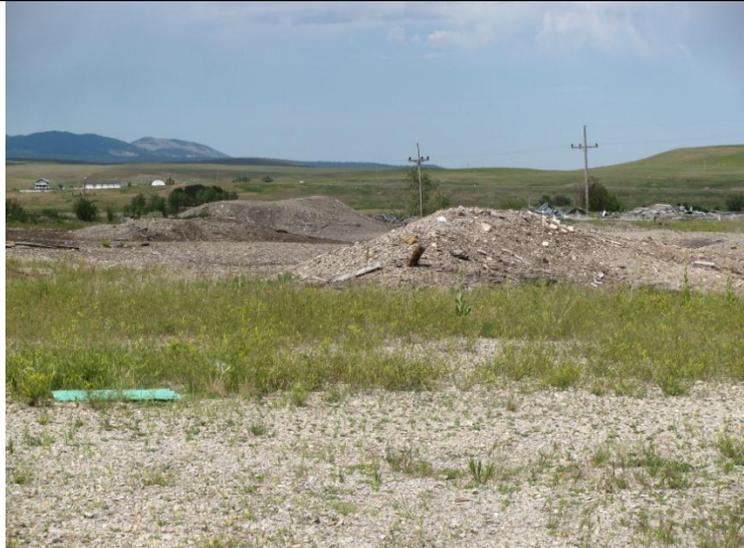
Figure 12-1 – This photo displays a portion of the surface detritus that remains on the Berg Lumber Mill site. This will be removed throughout the course of this project. [Photo: H. Janssen, August 2010]

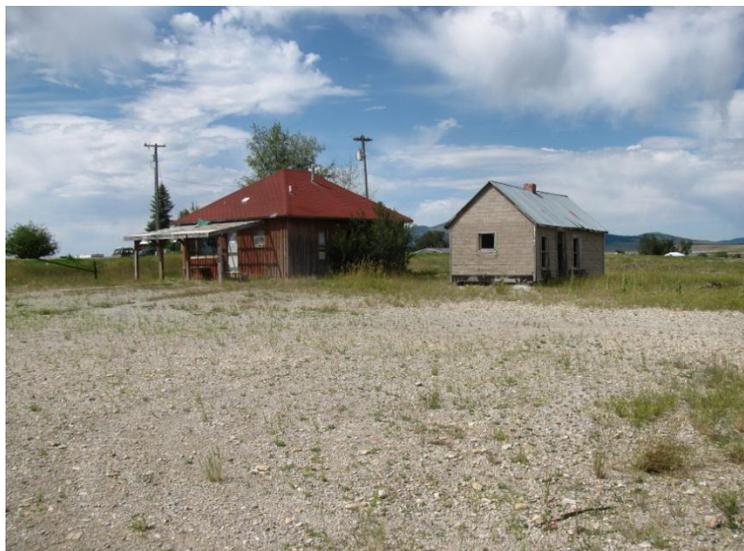
Figure 12-2 – These structures left on the Berg Lumber Mill Site are laced with lead-based paint and insulated with asbestos-based insulation. They will require removal. [Photo: H. Janssen, August 2010]

A Phase I EA occurred at the site in April 2001. This was followed in August 2004 by a Phase II EA to determine the extent of pollution at the site. In April 2010, it was determined that in addition to soil and groundwater contamination, the presence of asbestos and lead-based paint would require the removal of several existing structures on the property [Figure 12-2].

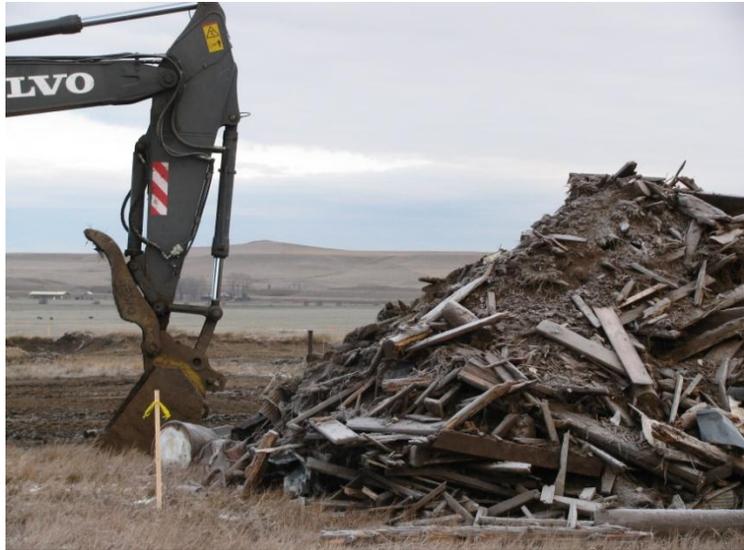
Figure 12-3 – A pile of rubbish on the Berg Lumber Mill Site awaiting disposal at the High Plains Landfill in Great Falls. [Photo: H. Janssen, November 2010]

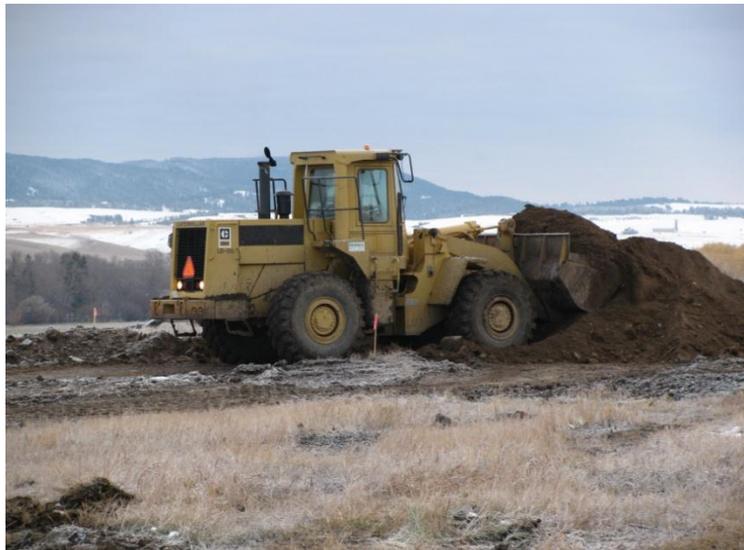
Figure 12-4 – Contaminated soils were stockpiled while awaiting transit to the High Plains Landfill. [Photo: H. Janssen, November 2010]

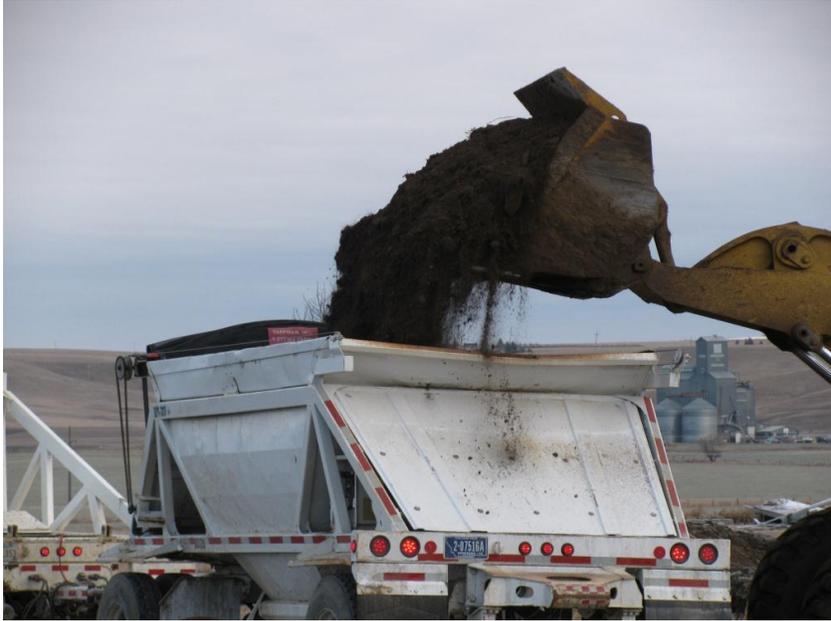
Figure 12-5 – Topsoil was loaded into semitrailers for transit and disposal. Each semitrailer was capable of transporting 32-40yds³ of soil per trip. There is an estimated 10,000 yds³ of contaminants at the Berg site that will require disposal. [Photo: H. Janssen, November 2010]

Present work consists of removing the DEQ estimated 10,000yds³ of contaminated soil. Samples taken from the most-affected areas have not measured contamination to a depth exceeding 12". Soil is presently excavated and placed on semi-trailers [capacities range from 32-40 yds³ per trailer]. It is hauled to the High Plains Landfill in Great Falls, a distance of 115 miles, one-way. Owing to the distance involved in disposing of this waste in a landfill certified to accept such material, five trucks make this journey, twice per day. Roughly 320-400 yds.³ of waste are removed and disposed of each day, with excavation activities at the site continuing throughout the workday.

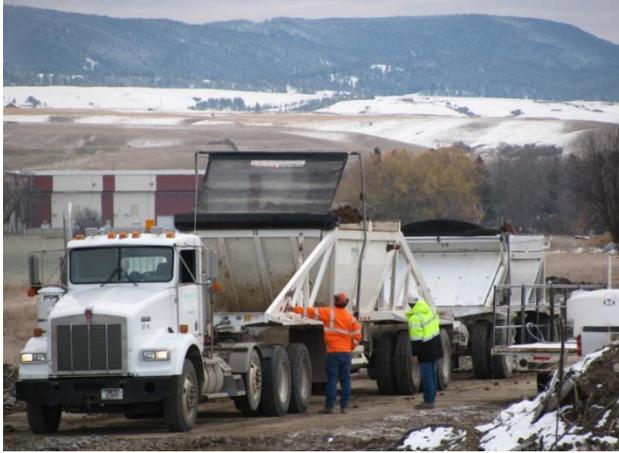
Figure 12-6 – Contaminated soil being secured for transit to the landfill. This action is mandated by state regulations and prohibits the impacted soils from becoming airborne while in transit. [Photo: H. Janssen, November 2010]

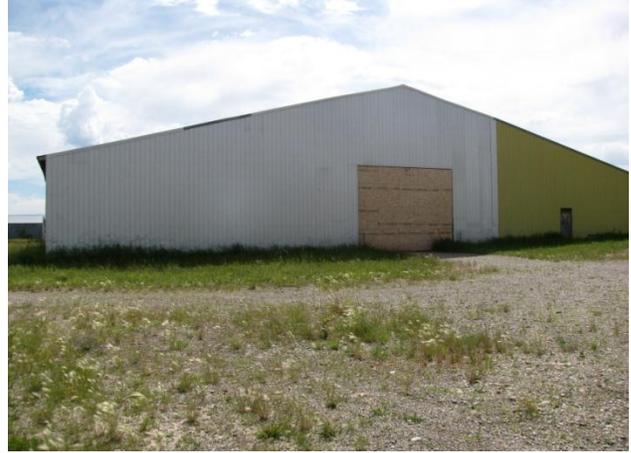
Figure 12-7 – A historic warehouse that will be removed from the site owing to its contamination with lead-based paint and asbestos has sat neglected for many years. [Photo: H. Janssen, August 2010]

Asbestos abatement at one of the surface structures was undertaken by Schroeder Contracting [Billings]. For this service, Schroeder received \$3,000. This employed 2 employees for a total of 40 hours. Schroeder employee wages range from \$18-20/hr.

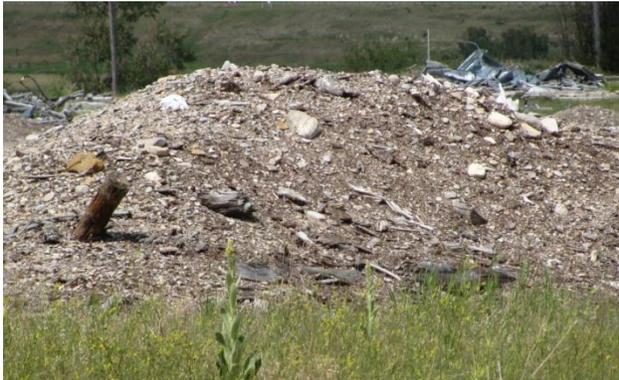
Figure 12-8 – One of several piles of rubbish on the Berg Lumber Mill Site property awaiting disposal. [Photo: H. Janssen, August 2010]

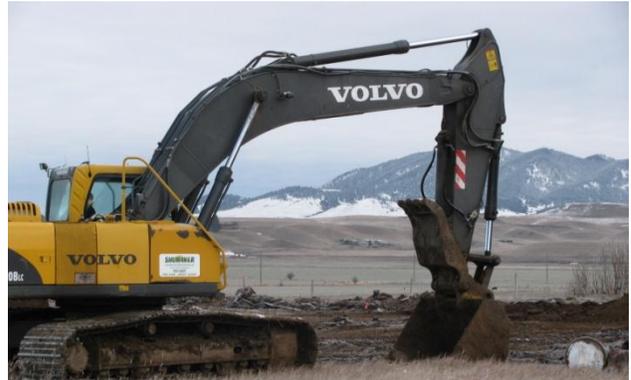
Figure 12-9 – Topsoil being removed from the Berg Lumber Mill Site. Contaminated topsoil was removed to a depth that has not yet exceeded 12" throughout the property. [Photo: H. Janssen, November 2010]
